Inspection Report

Property Address:
123
Tacoma WA 98418

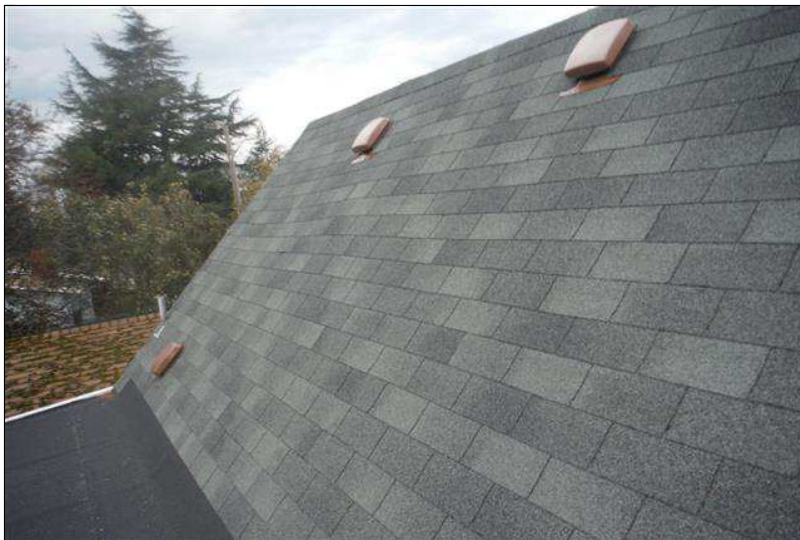
The roof has 2 different styles to it. One is heavily pitched and the other is flat. The flat roof has a composition type shingle on and that is not standard for a flat roof, composition shingles should be layed on a 4/12 pitch or greater. The PVC style roof looks good but has some spots on the under laments where it was leaking and not repaired.

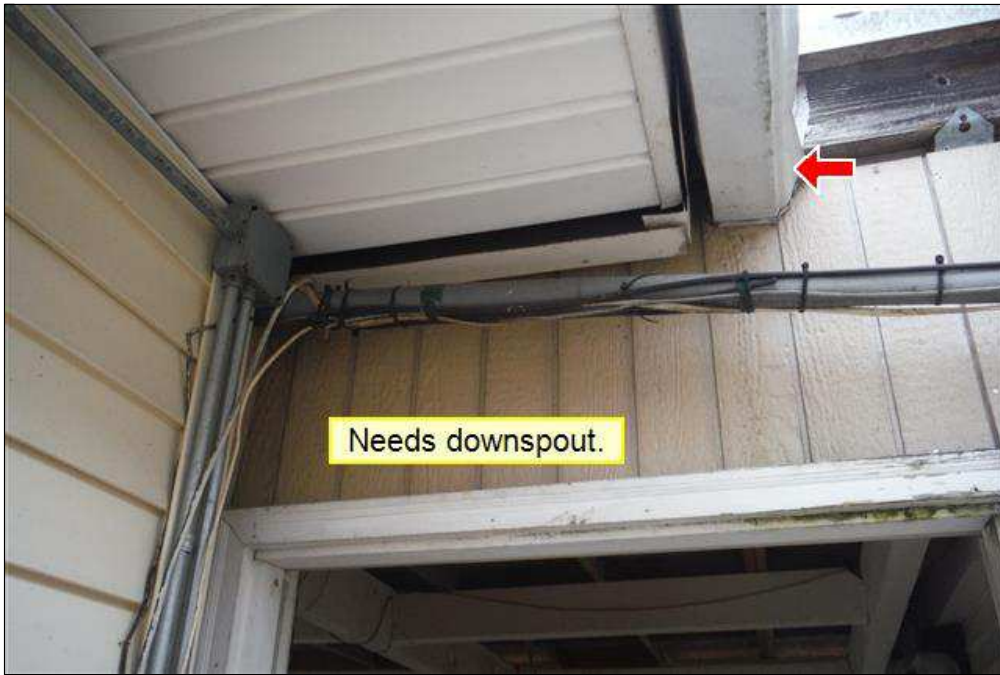
Missing a downspout on the rear of the home. The rest of the gutter system needs to be routed away from the foundation as it is causing a pond on the front of the home.

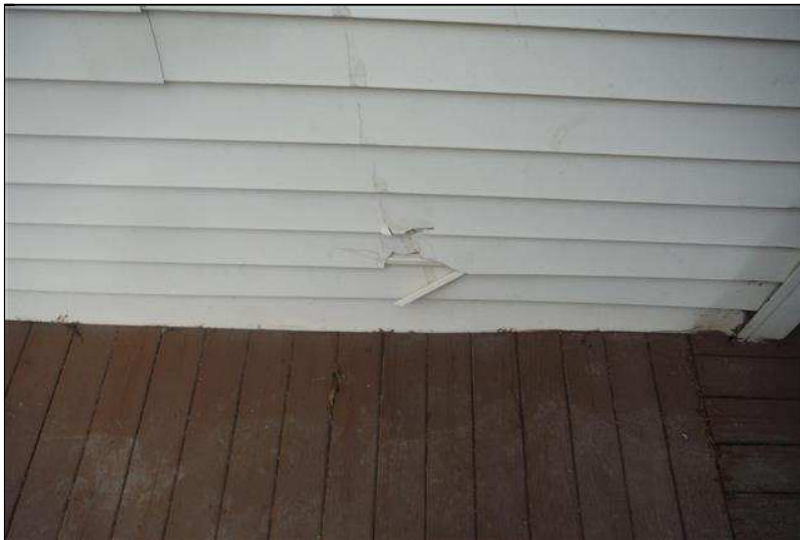
The vinyl skirting on the home must be replaced.

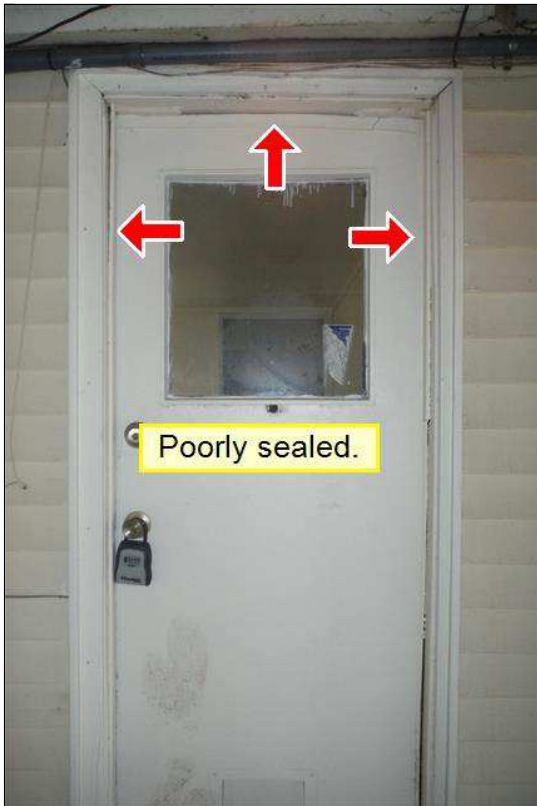
Both exterior door have gaps around them that must be sealed.

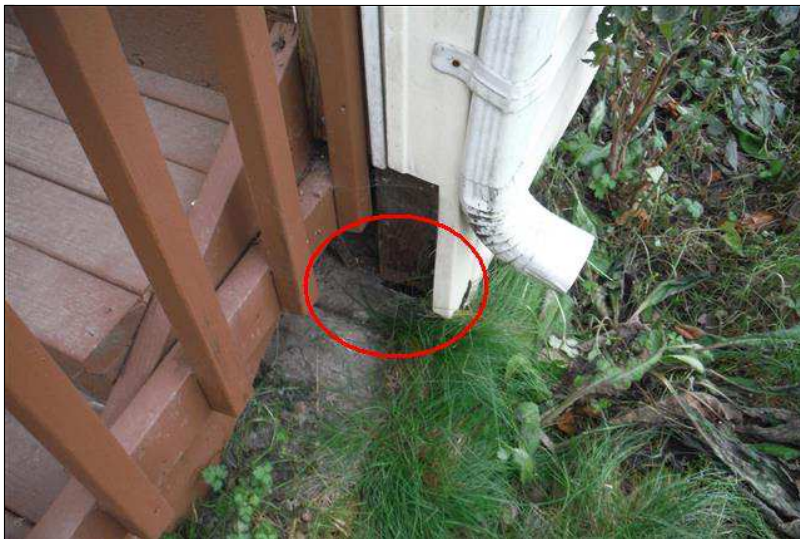
The front porch is missing posts due to the pond being created by the downspouts. Also has rotted the support for the front porch.

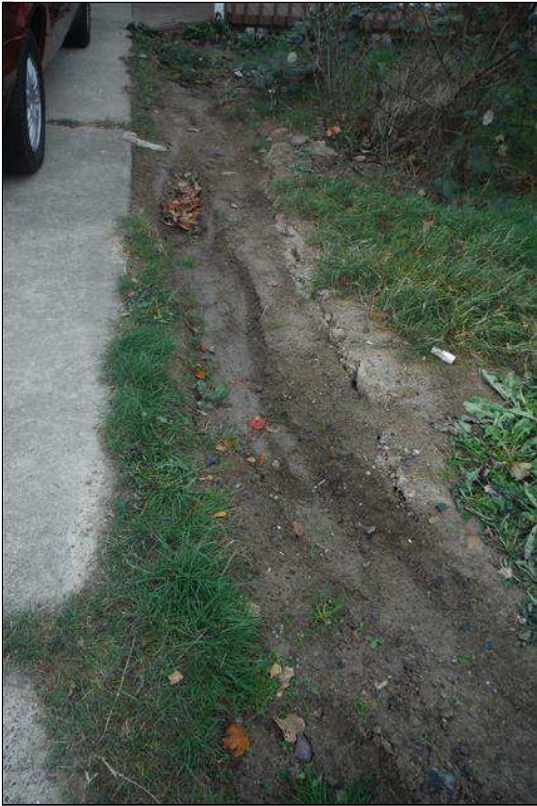
The grading on the front of the home slopes towards the house and should be corrected. There is also a run near the driveway (which is also sloped towards the home) that looks like it will create water going back to the home during the rainy season.

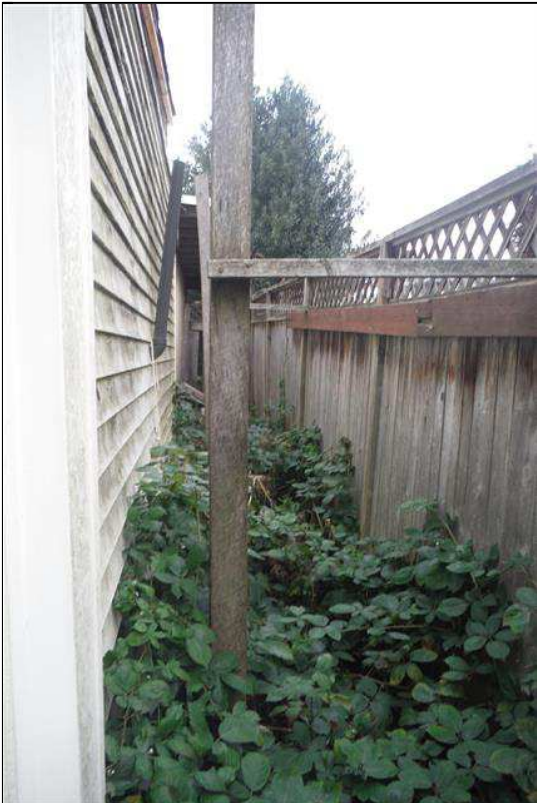
Comments: Inspected, Repair or Replace
Damaged fence must be replaced.

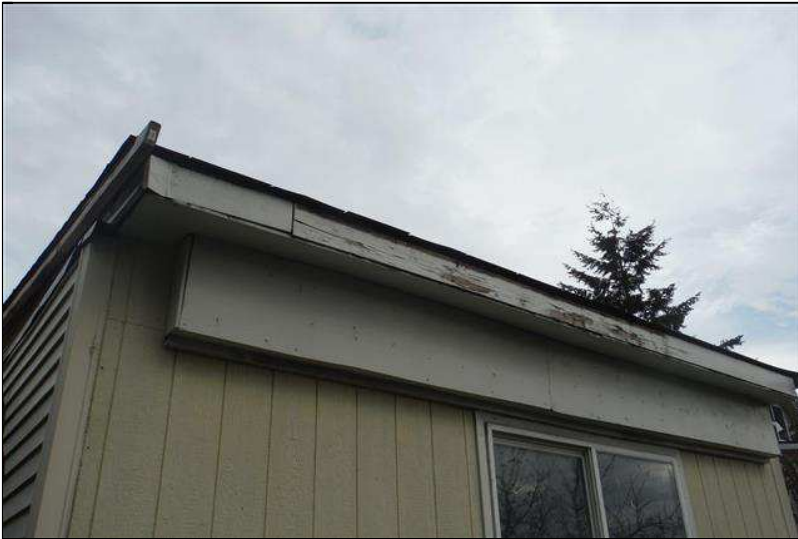
All bare wood must be painted or it will rot.

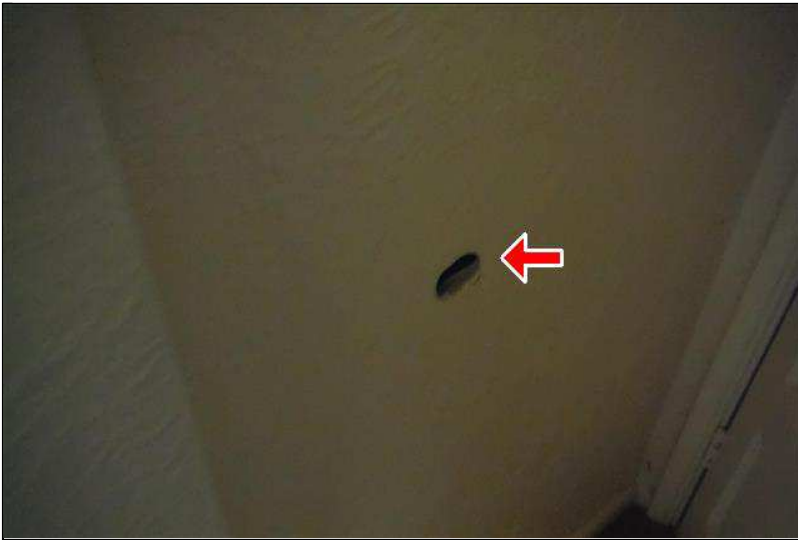
Comments: Inspected, Repair or Replace
Operating properly at time of inspection. Hole behind bathroom door needs repair.

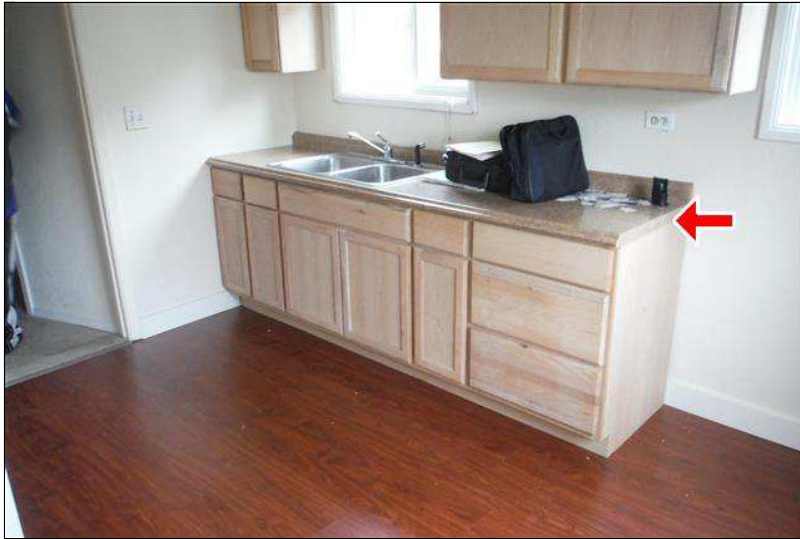
Comments: Inspected, Repair or Replace
Not secured to the cabinets, which were also poorly installed in the kitchen.

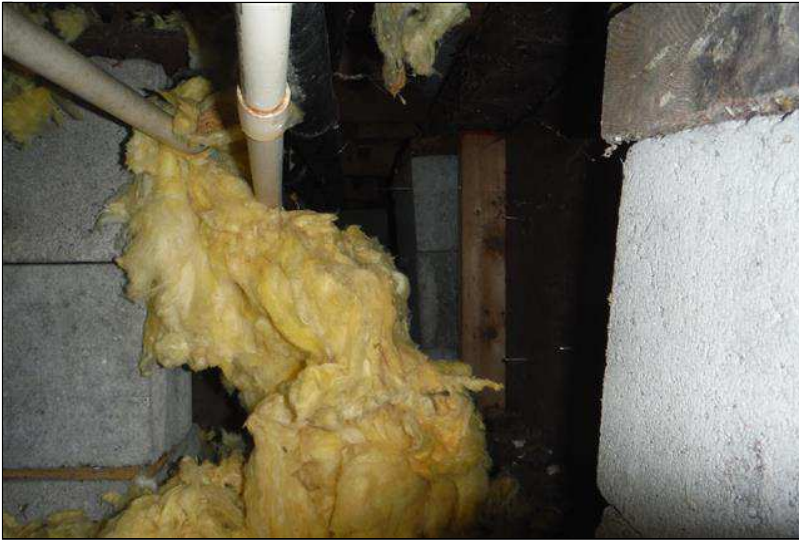
I was unable to full inspect but from walking on the floor is was uneven and will require repair.

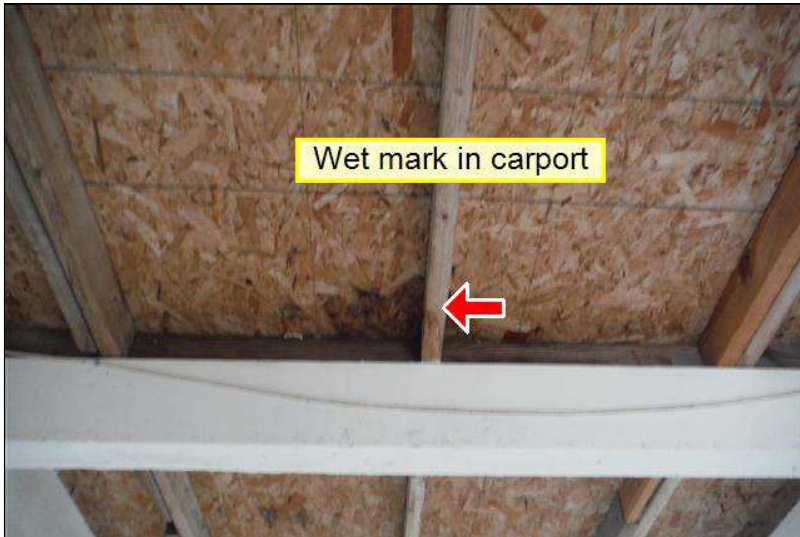
The attic appears to be in good condition; however, the sheathing under the carport and under the flat roof area must be replaced as it is damaged.

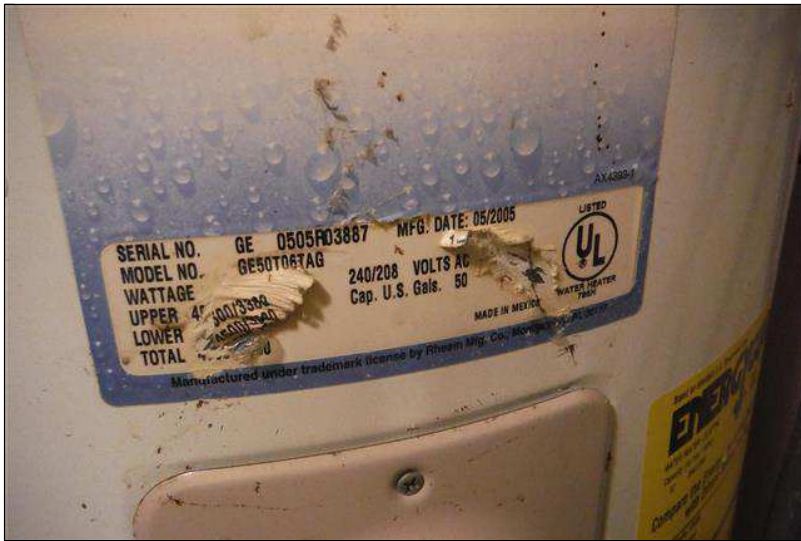
The water heater is rusting, full of rodent droppings and needs replacement, a drain pan and an expansion tank and seismic straps installed. It also needs the PRV to extend to the exterior of the home.

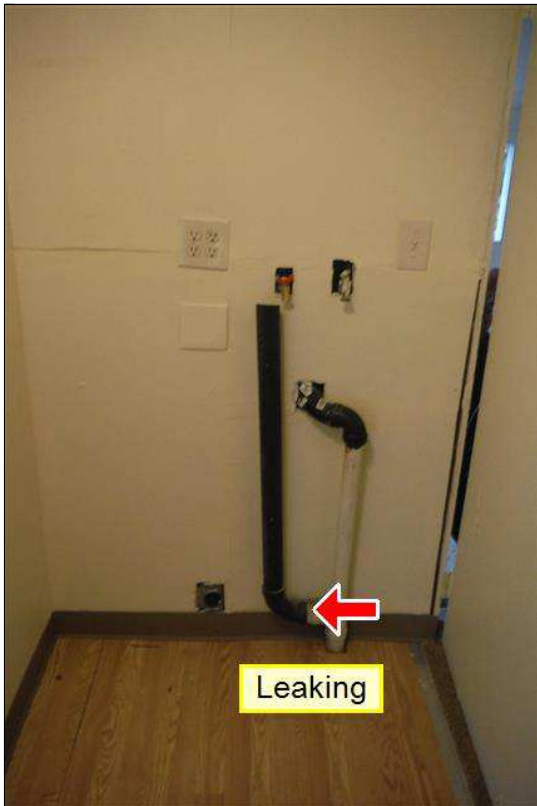
Comments: Inspected, Repair or Replace
Washer drain line is leaking.

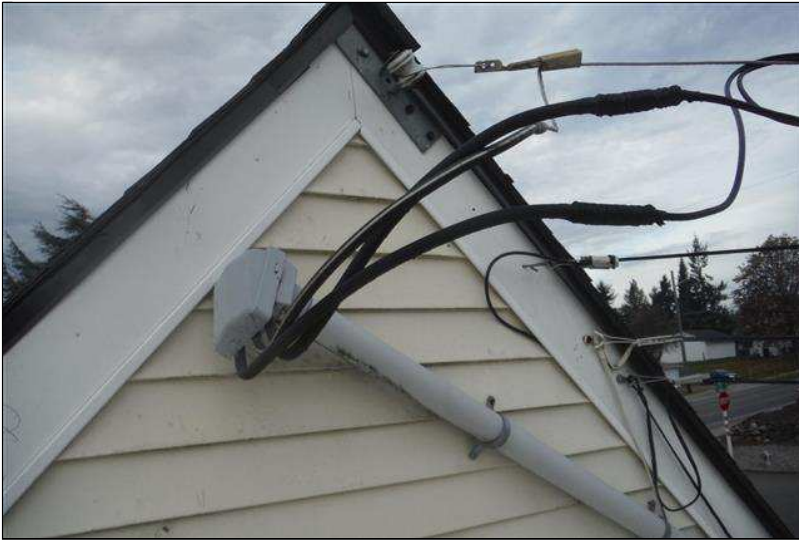
Operating properly at time of inspection. Seal the mast.

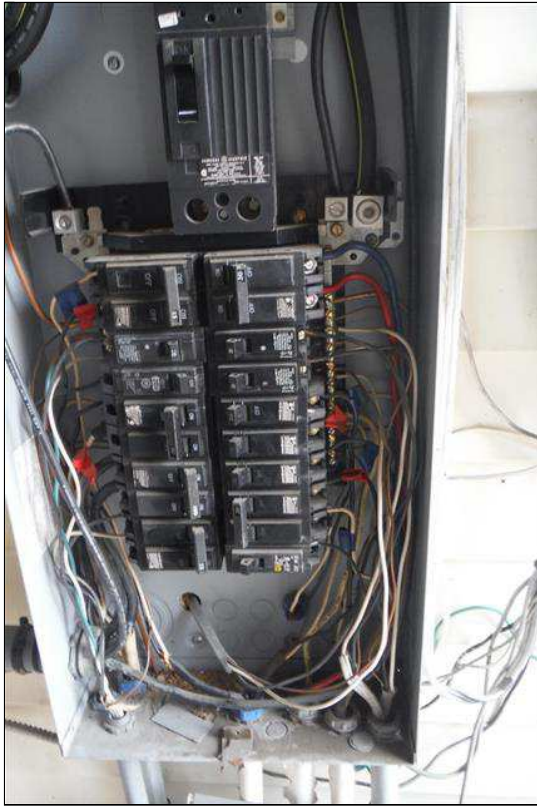
Operating properly at time of inspection.

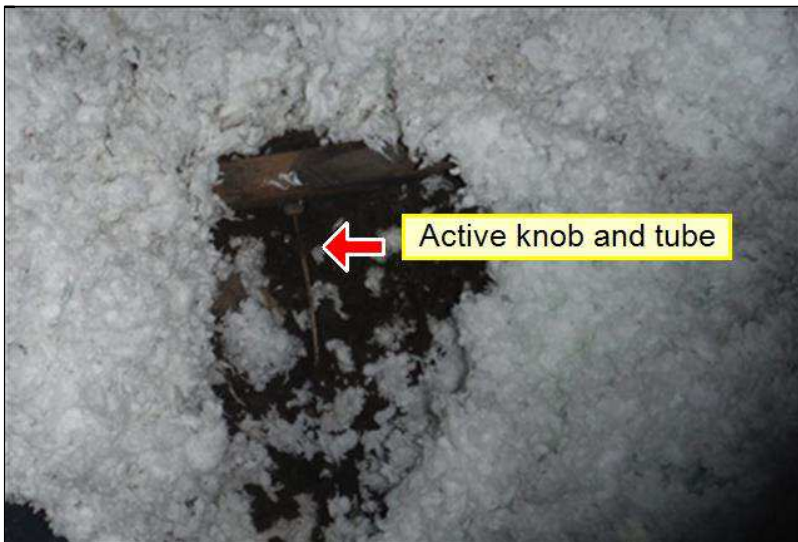
Many outlets are ungrounded and the home is still operating on the knob and tube wiring in the attic. It is not possible to get insurance on a home with knob and tube that is covered with insulation. This must be re-wired and done by a licensed electrician.

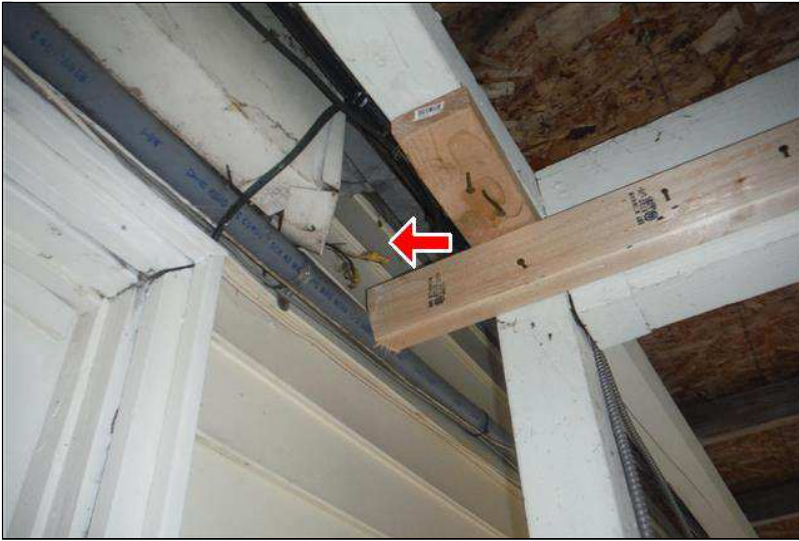
Open ground in the main bathroom. Open electrical wires in the carport must be covered. The switch on the outside of the home (carport) has a non working GFCI and an extension cord wired into it. This is not code, also all exposed (romex) wiring must be in conduit on the outside of any dwelling.

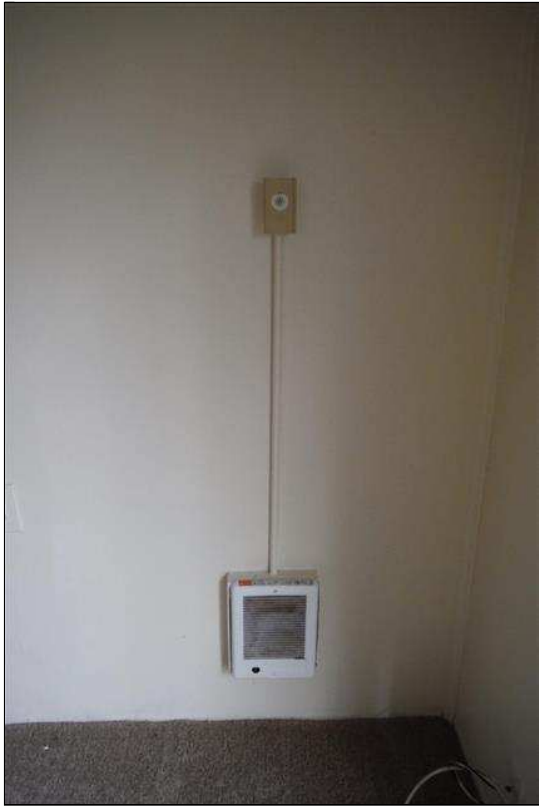
Only 1 of the heater works in the home.

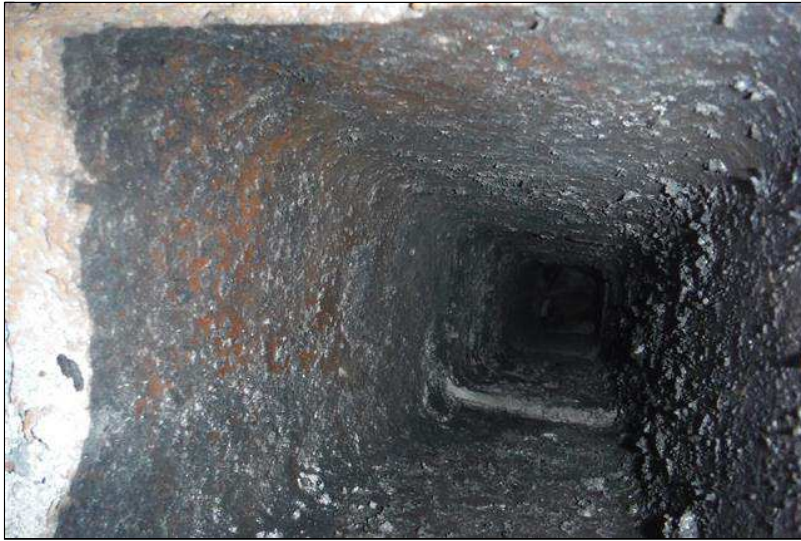
Comments: Inspected, Repair or Replace
The chimney ends in the attic.

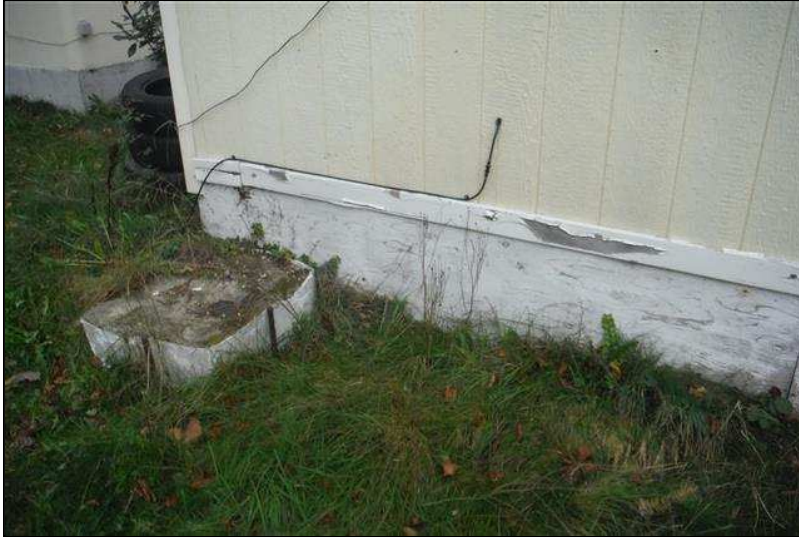
10.3 Item 1(Picture)

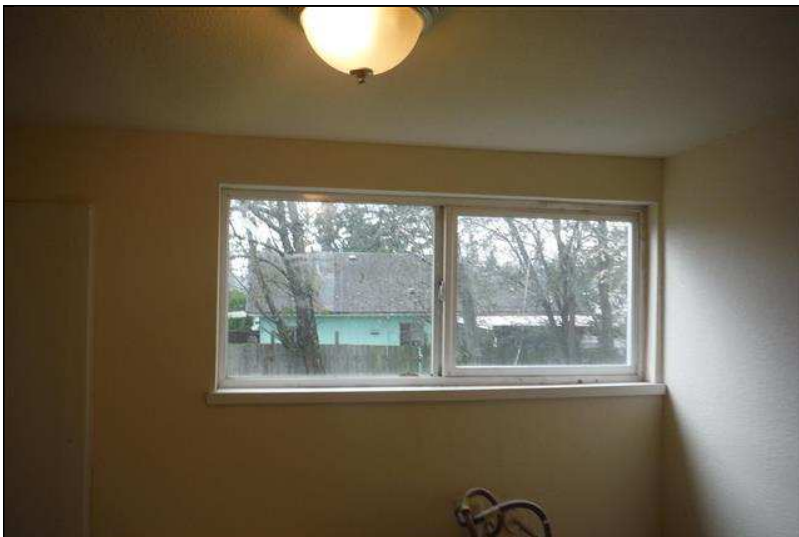
10.6 Item 1(Picture)

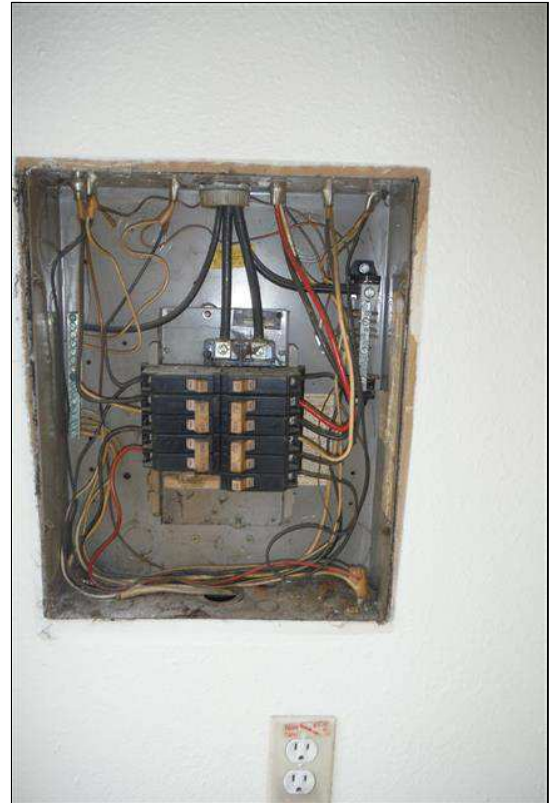
10.7 Item 2(Picture)

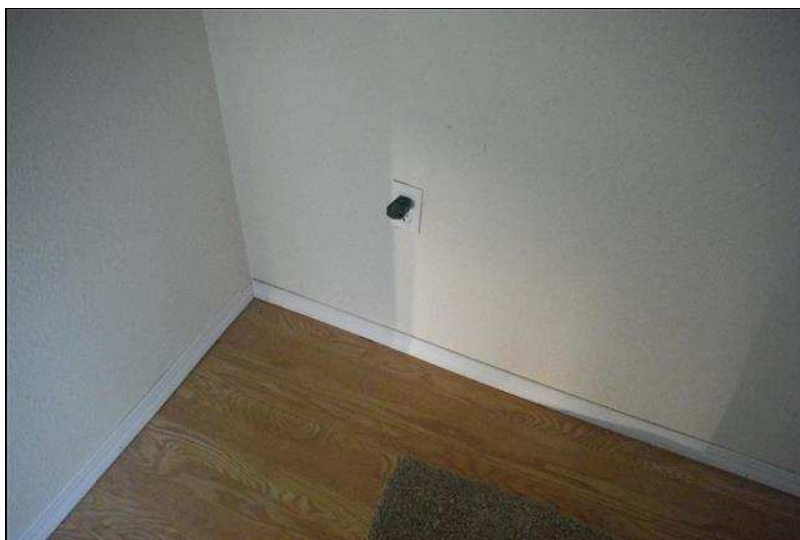
10.8 Item 1(Picture)

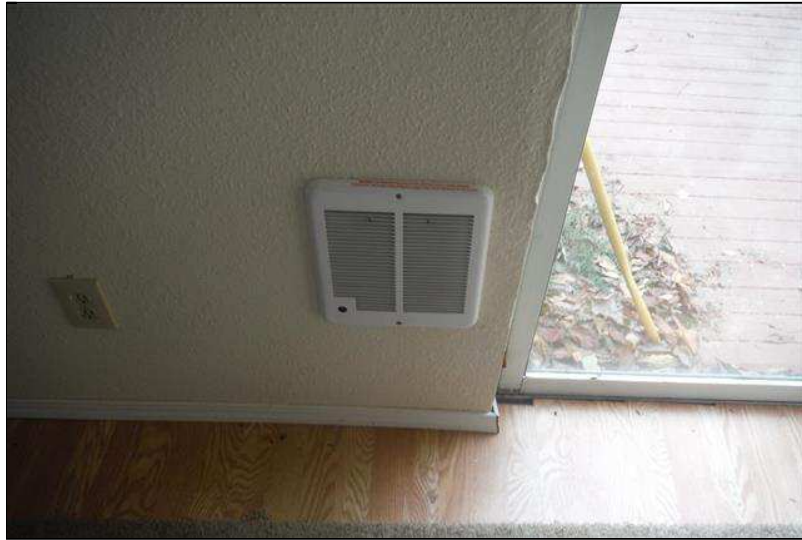
10.11 Item 1(Picture)

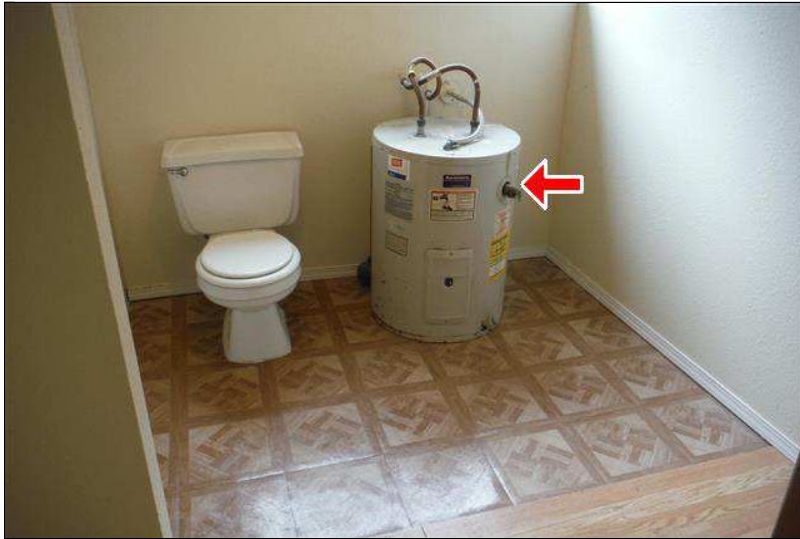
10.14 Item 1(Picture)

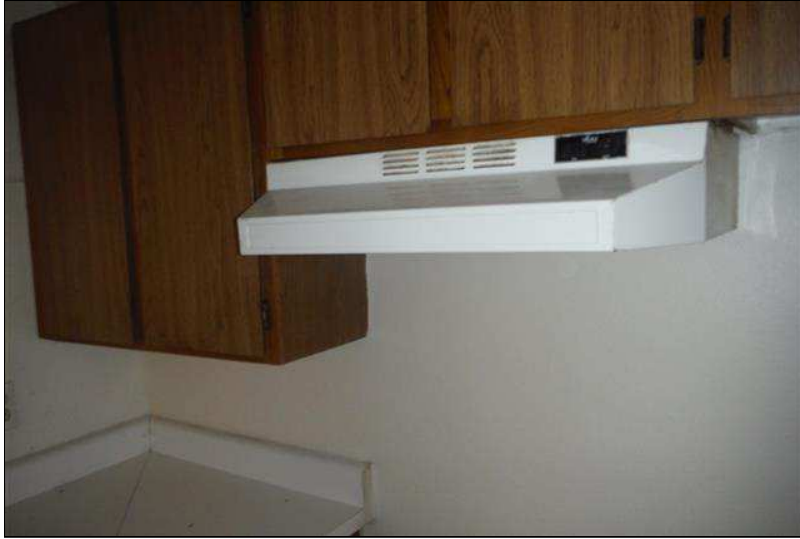
10.16 Item 1(Picture)

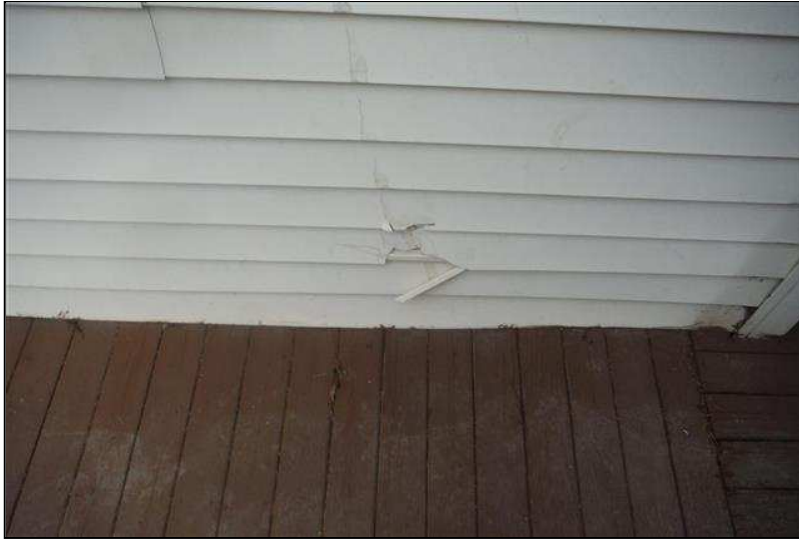
The vinyl skirting on the home must be replaced.

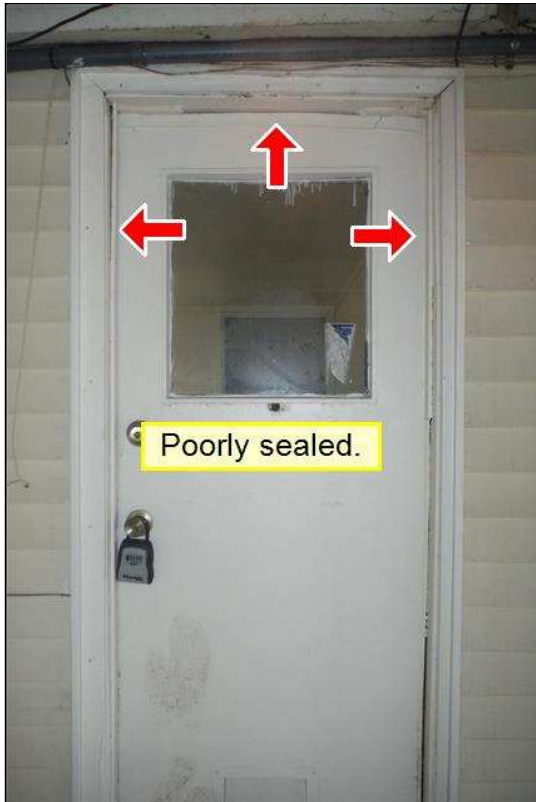
Both exterior door have gaps around them that must be sealed.

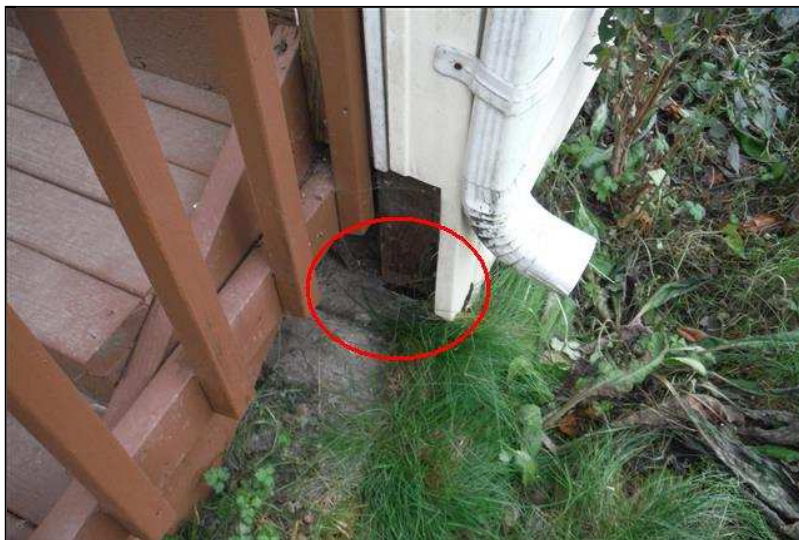
The front porch is missing posts due to the pond being created by the downspouts. Also has rotted the support for the front porch.

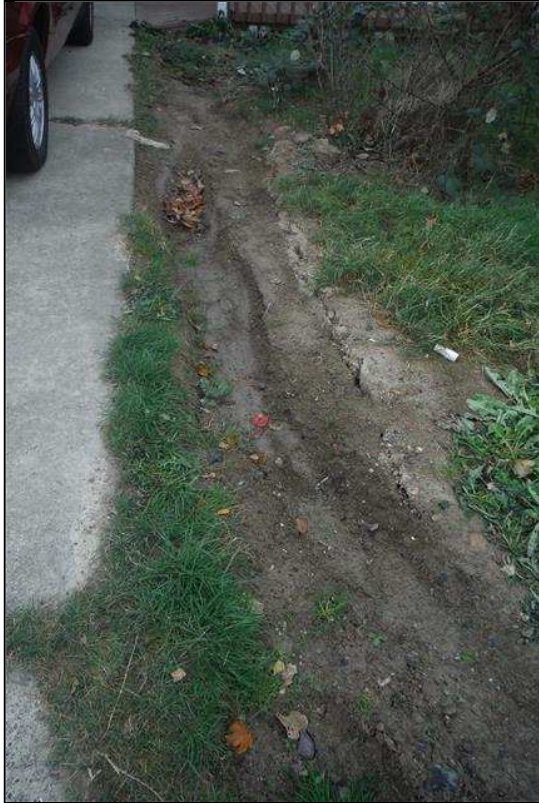
The grading on the front of the home slopes towards the house and should be corrected. There is also a run near the driveway (which is also sloped towards the home) that looks like it will create water going back to the home during the rainy season.

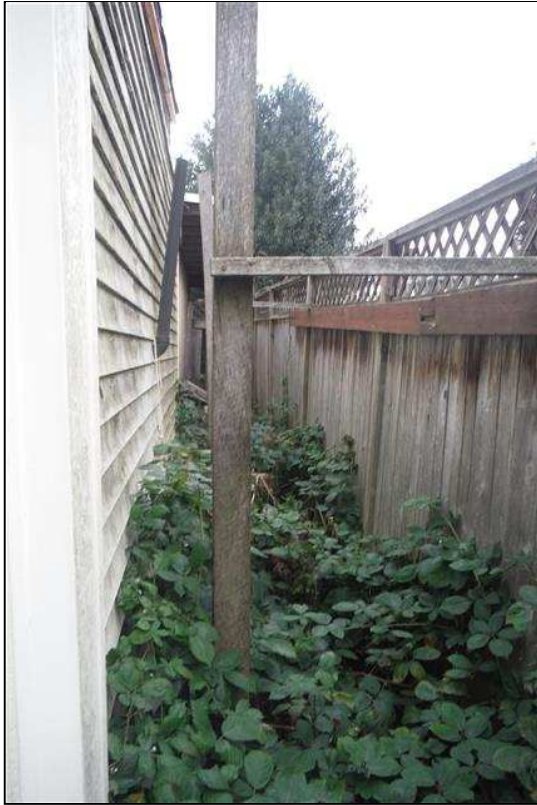
Damaged fence must be replaced.

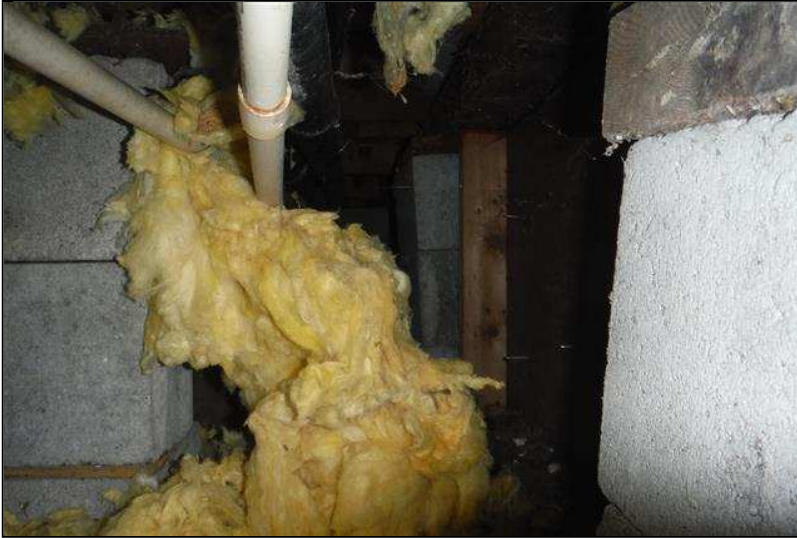
4. Structural Components

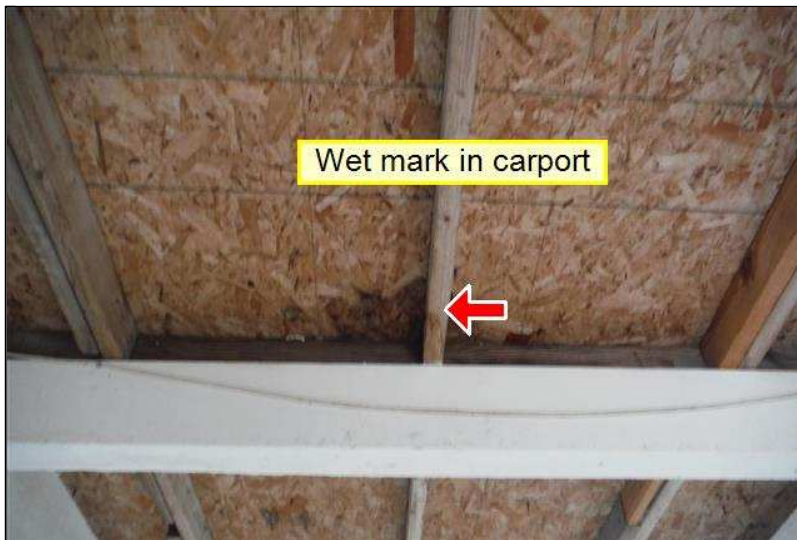
The attic appears to be in good condition; however, the sheathing under the carport and under the flat roof area must be replaced as it is damaged.

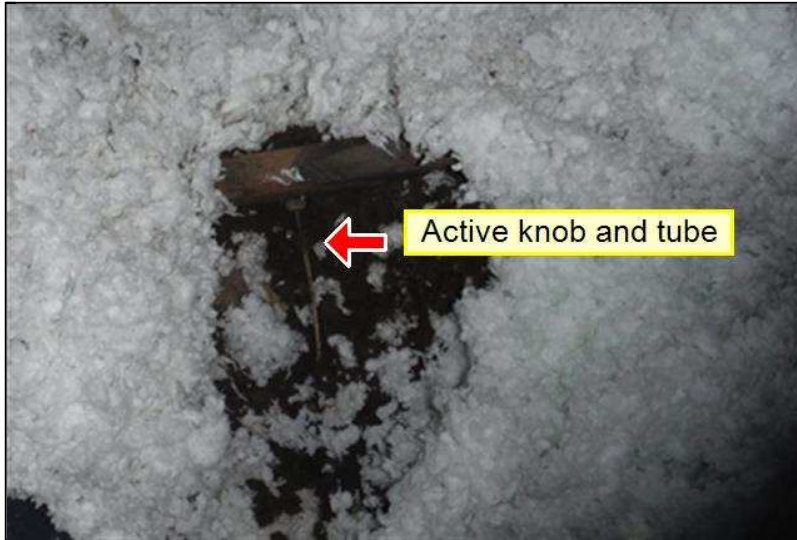
6. Electrical System

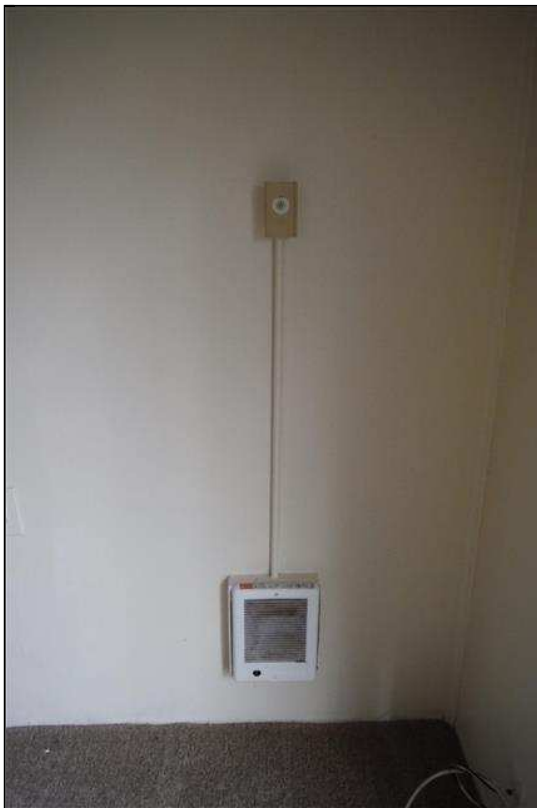
Only 1 of the heater works in the home.

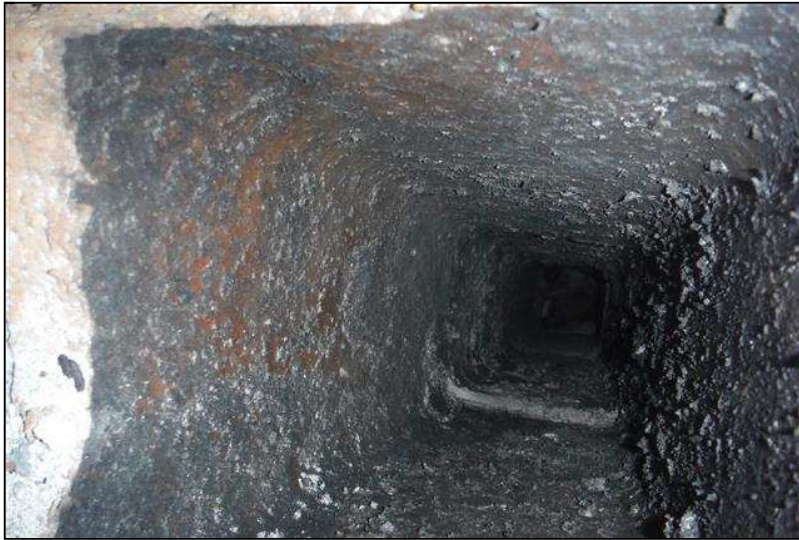
7. Heating / Central Air Conditioning

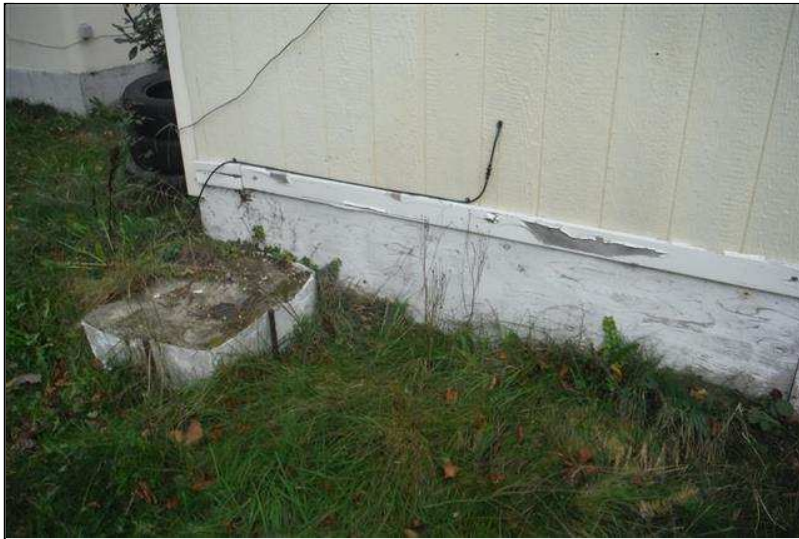
10.3 Item 1(Picture)

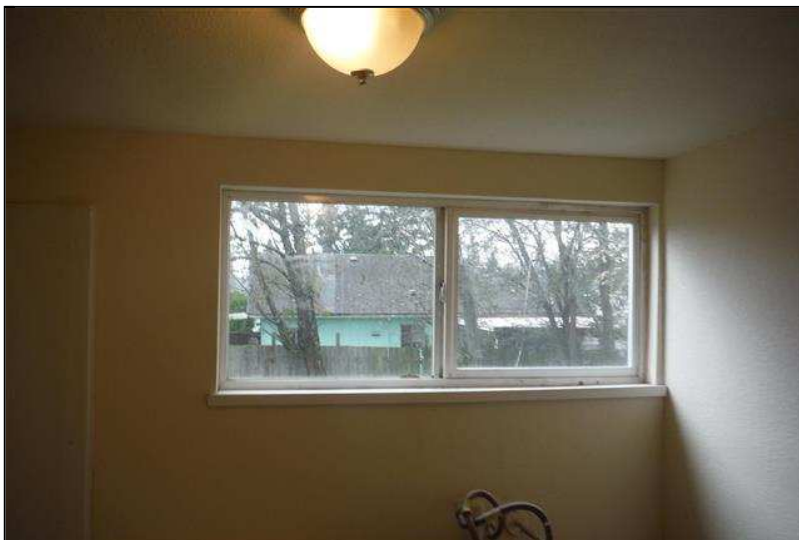
10.6 Item 1(Picture)

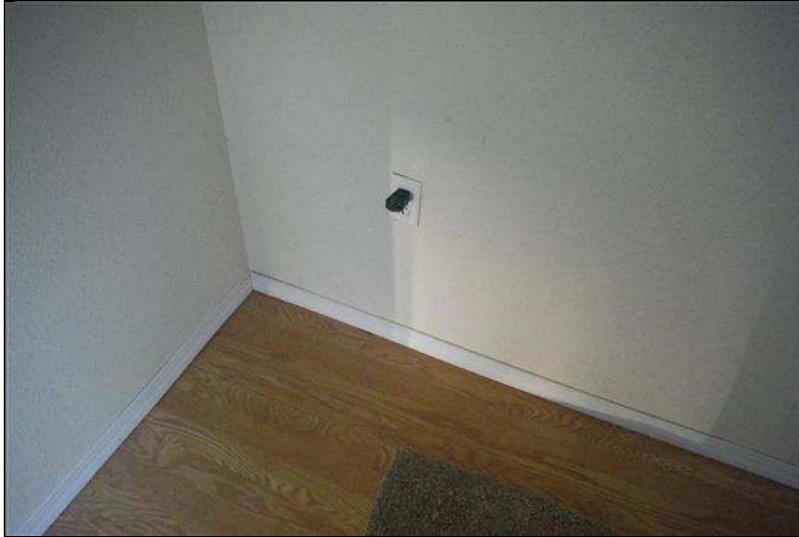
10.8 Item 1(Picture)

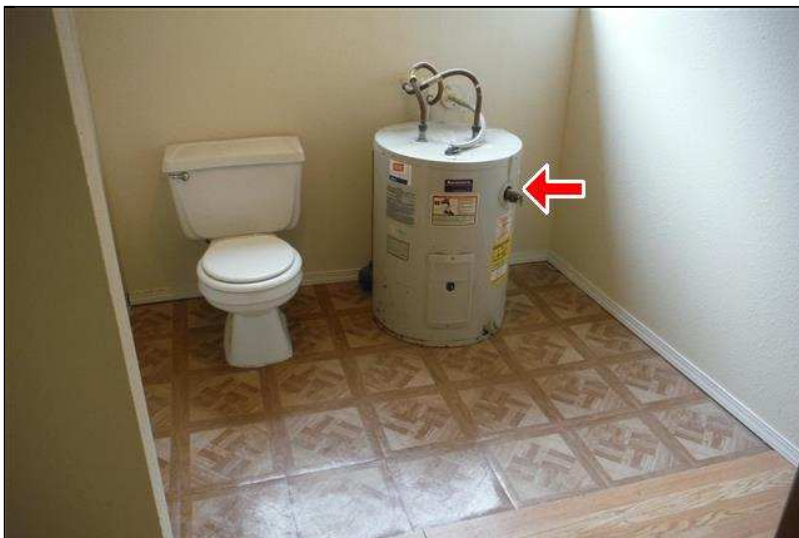
10.14 Item 1(Picture)

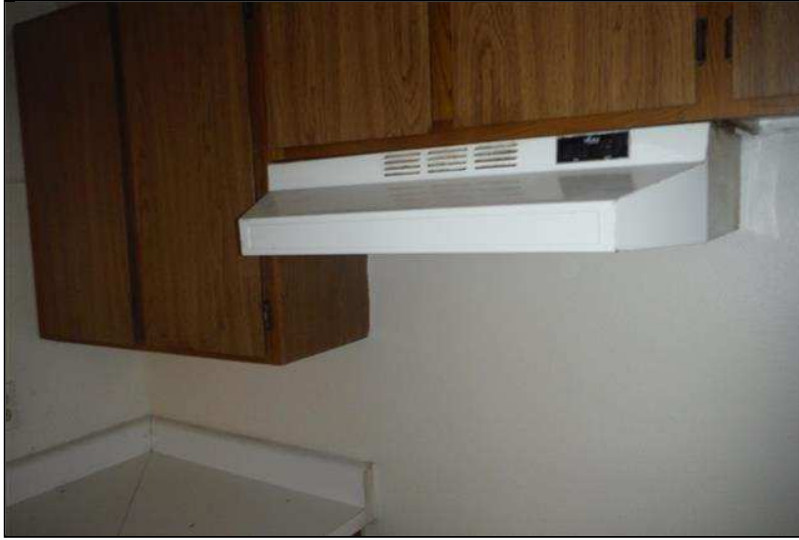
10.16 Item 1(Picture)
